# Manhole Inspection Summary

Manhole # S05AA2022MH

**Location** Address: **6009 WESTERN RUN DRIVE** Cross Street: **BAYWOOD AVE**

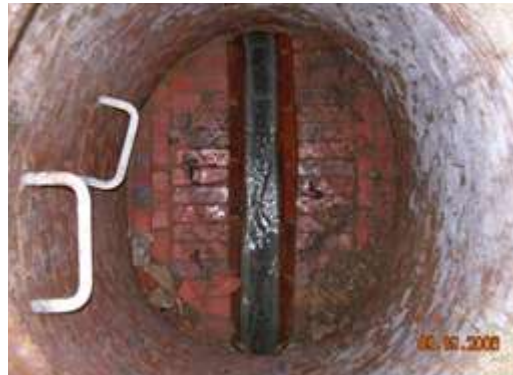
**Manhole** Type: **Inline** Location: **Sidewalk** Ground Conditions: **Dry**  
☐ Prev. Rehab Weather: **Dry** Subject To Ponding: **None**  
Comments **The I7 pipe seal is not flush to the pipe. The Top View picture shows grease deposits in the Channel.**

Adjustment and Barrel infiltration.  
Evidence of surcharge - Bench debris.

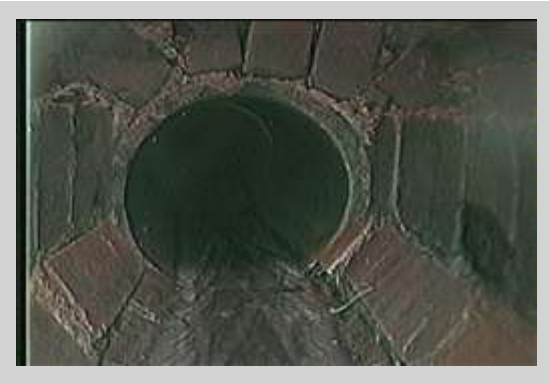
### 8 in. Circular Gravity Sewer Pipe Out @ 12 O'Clock

Barrel deterioration and infiltration.

Infiltration: **Evidence** Pipe Seal Cond: **Unknown**

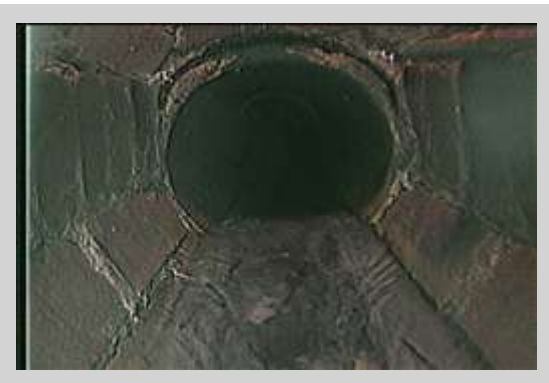
### 8 in. Circular Gravity Sewer Pipe In @ 7 O'Clock

Channel deterioration.

Infiltration: **Evidence** Pipe Seal Cond: **Unknown**
